# Manual for Rehabilitation Work of Irrigation Facilities

(Check Points for Better Design and Construction)

Technical Cooperation for Capacity Development  
for the Promotion of Irrigation Scheme Development  
under the District Agriculture Development Plans (DADPs)

April 2016

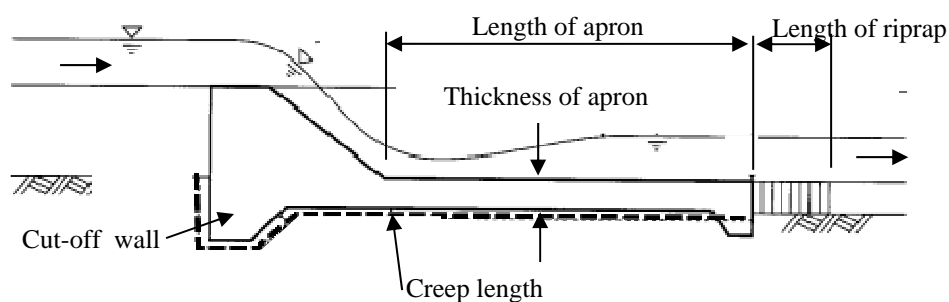
Figure 3-1 Model of the apron

In case of designing a head work, several dimension of the apron should be secured to prevent the damages and malfunctions of facilities from floods. Then, required creep length, thickness and length of apron, etc. shall be decided using following calculation.

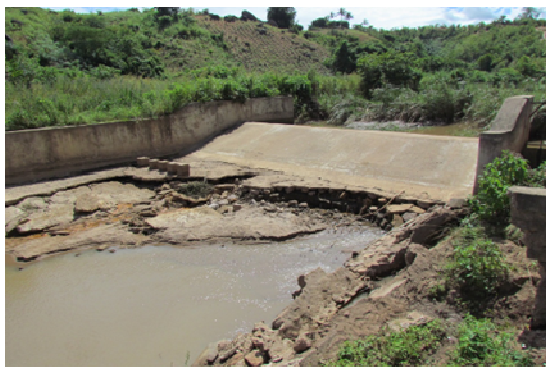
Example of Kimbande scheme (Nyasa, Mtwara)

Base concrete washed away

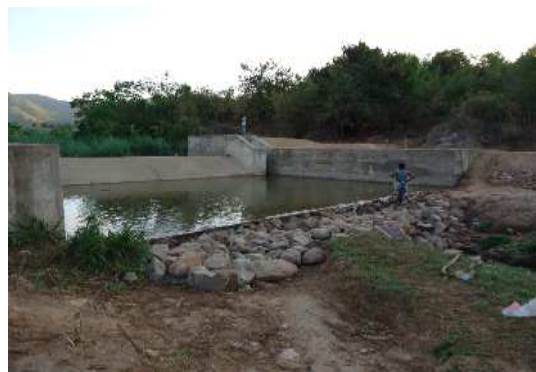
Completed

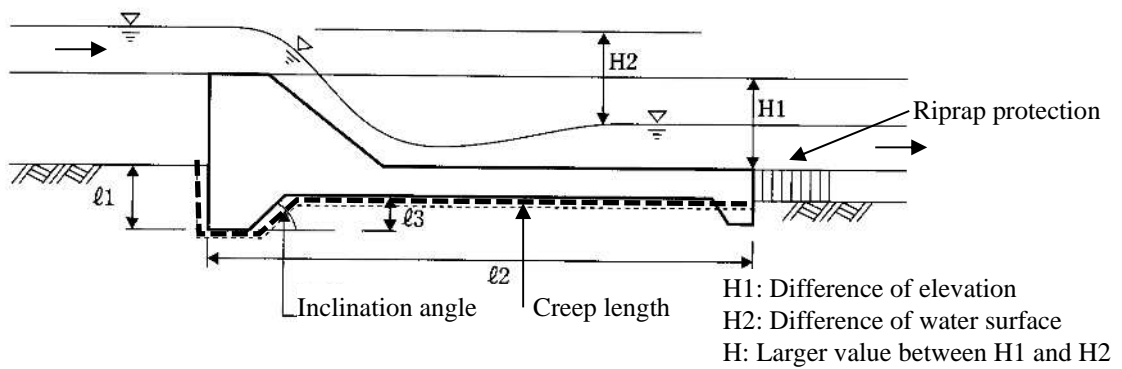
Figure 3-2 Profile of apron

Creep length below must be ensured when a weir is constructed on the pervious foundation. Larger creep length estimated by the following equations (Bligh's method and Lane's method) is ensured.

H : Maximum head difference at upstream and downstream sides (m)

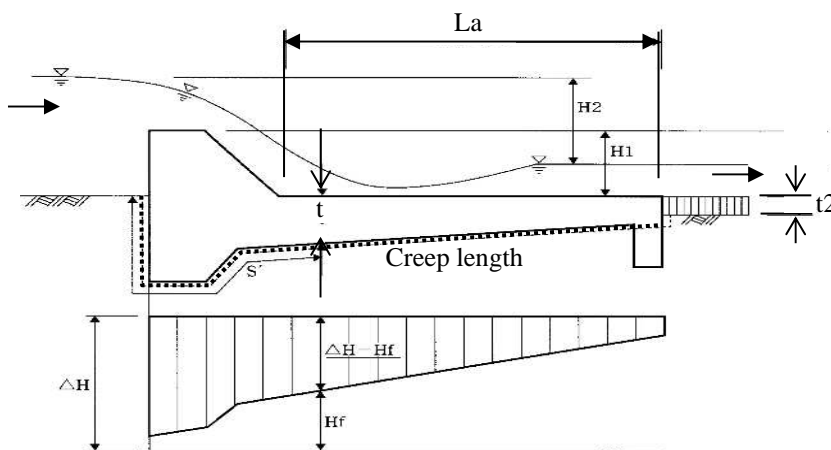
Figure 3-3 Thickness of the apron

$$H_f = \Delta H / S \times S'$$

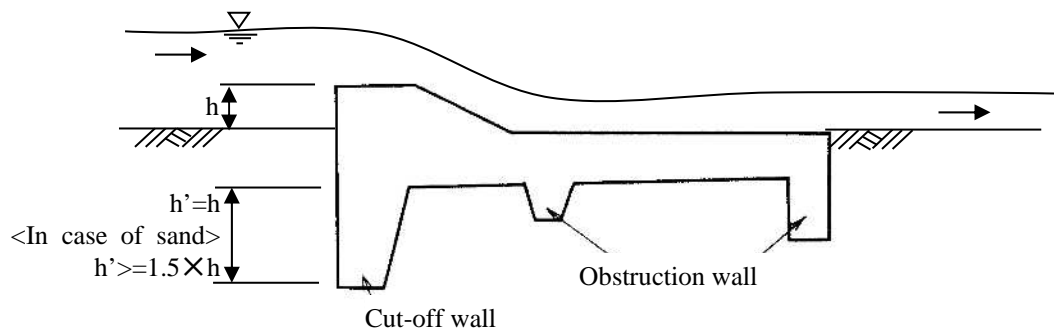
Figure 3-4 Cut-off wall and obstruction wall

Cut-off wall to restrain the excessive seepage and to secure the safety the dam body by prevention the piping, obstruction wall against scouring of river bed caused by water flow shall be installed respectively.

Obstruction wall to protect the dam body against scouring of downstream shall be installed in consideration of the river bed situation, soil type, structure of riprap protection, and so on.

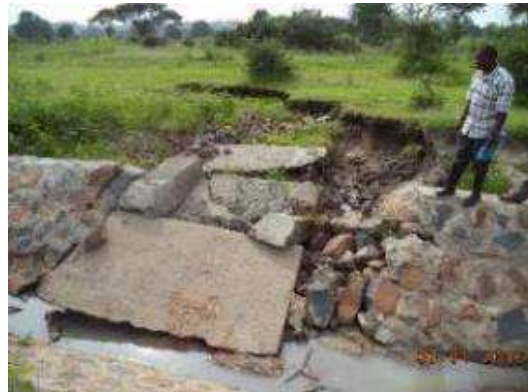
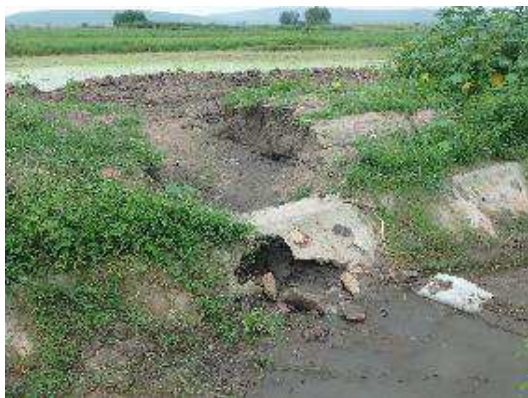
Especially, lining canals are susceptible to be damaged by overflowing of floods from lateral direction of the canal.

Collapsed canals by overflowing of floods

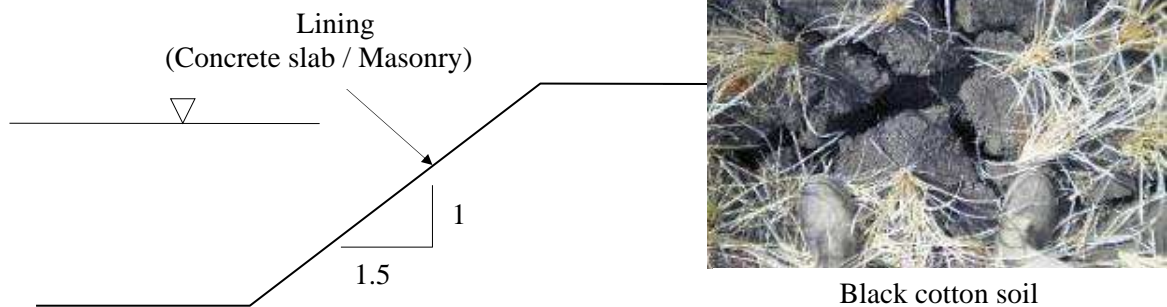
Figure 3-6 Side slope for lining canal

Side slope as 1:1.5 may minimize a collapse of the side wall of canals. In the case canal slope is protected with a concrete slab or masonry lining, replacement of surface portion with another soil may effective to keep the black cotton soil in stable moisture content, hence expanding and shrinking of the soil is minimized.

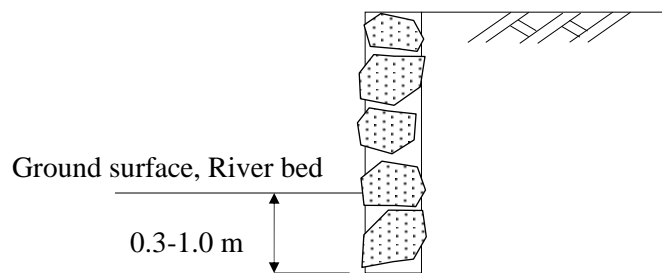
Figure 3-8 Embedment of Foundation

The depth of embedment of a structure shall be determined based on the basement situation although influenced by the topography condition. Moreover, when the structure is installed in the river, necessary depth should be ensured to prevent scouring of river bed.

When the gradient of longitudinal canal slope is gentle, the depth of embedment of a structure shall be 0.5 m. Moreover, when the canal slope is steep and risk of scouring or damage by stone flow is supposed, 0.7 – 1.0 m of embedment should be ensured.

The base of retaining wall shall be embedded into ground about 0.5 m or more to prevent scouring of the riverbed. When the river flow velocity is fast, more than 1.0 m of depth of embedment shall be proposed.

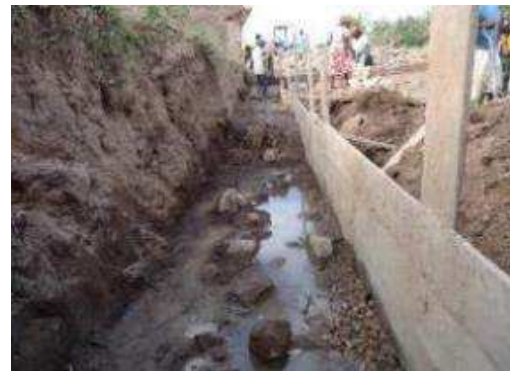
Embedment before concrete placement

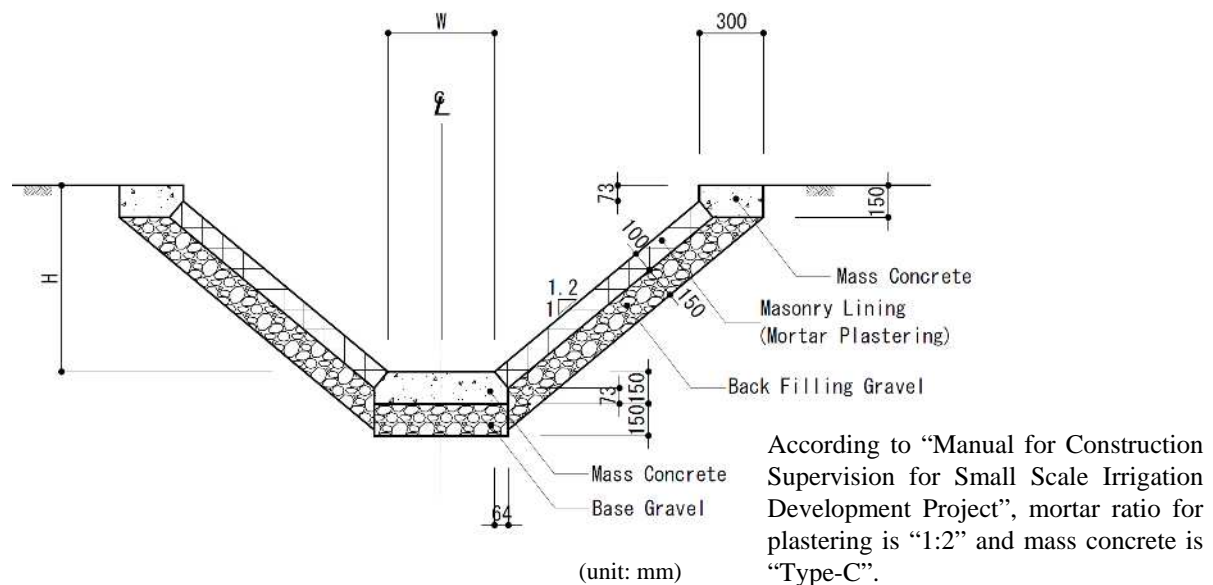
Figure 3-9 Drawing example of base concrete

The base concrete thickness of the canal shall be 0.15 m taking basement condition into consideration, beside 0.20 m should be ensured in case maximum velocity of water flow exceeds 3.0 m/sec. When the basement is not good, base gravel (thickness = 0.15 m) shall be employed if needed. Moreover, ground sill for the masonry structure is very important and the sill shall be made by concrete to support the upward load of the structure.

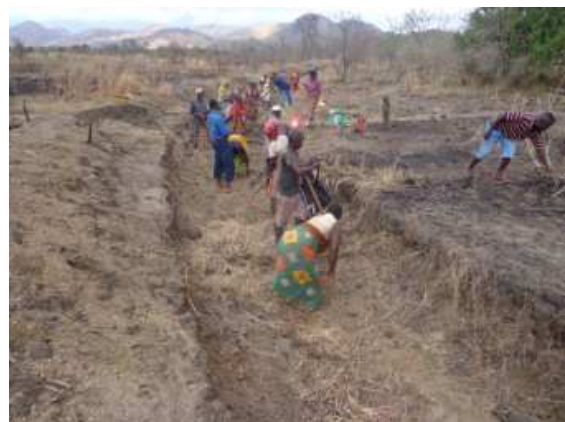
Catch drain by farmers' contribution

Catch drains that can safely remove the discharge during flood conditions shall be designed based on investigation results of the drainage area.

While the routes are located along the perimeter of the project area, they are frequently located inside of the bank in order to treat the seepage water.

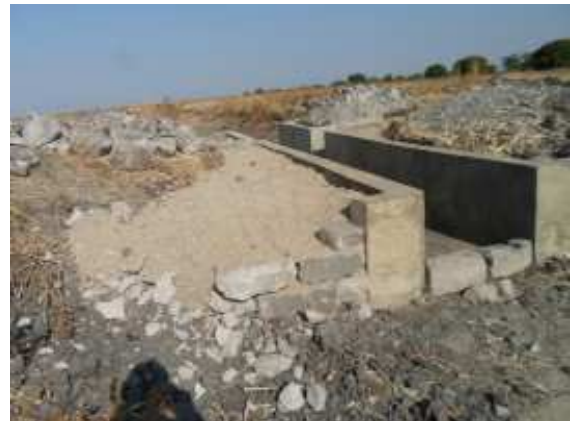
Similarly, reuse of these materials, such as masonry and natural soil, as a composition of the concrete should be avoided because the materials have possibilities to cause a strength drop by the contamination of soil and sand.

Concrete wreckage used as backfilling

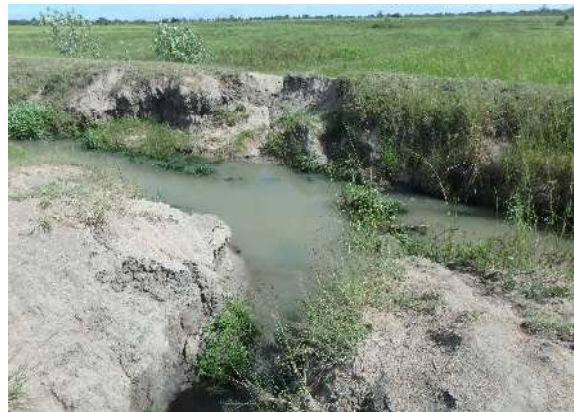
For example, in the embankment canals social impacts are considerably large, when embankments are breached under degradation such as piping. In the canals excavated on the natural ground, there are cases that land and roads along the canals are damaged by excavation or erosion on their side walls.

Erosion of side slope

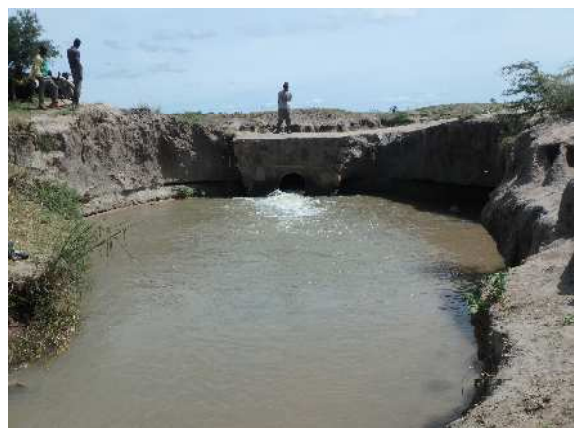
Scouring at the downstream of division structure

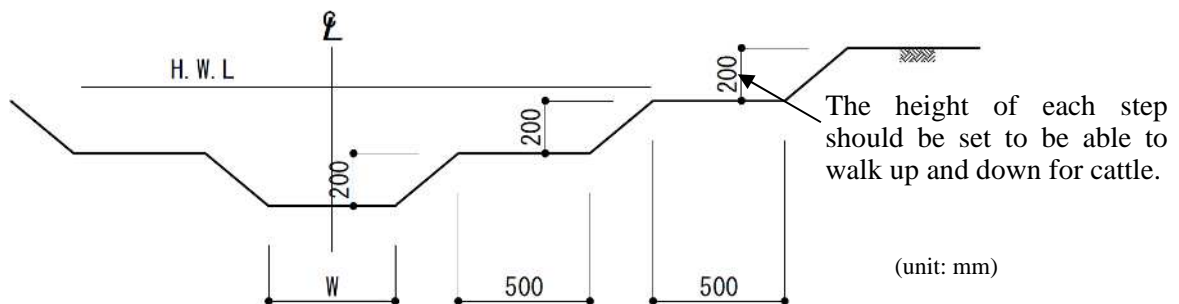
Figure 3-11 Image figure of cattle pass

In case of canal designing, traffic course of cattle shall be grasped beforehand and installation of small pass or bridge for cattle have to be considered.

Cattle are raised widely in Tanzanian rural area, and they go to feeding grounds from farmhouse every day. But they cannot come and go freely after construction of canals made by masonry or concrete slab and there are some cases that the side wall part of canal damages by the traffic of the cattle.

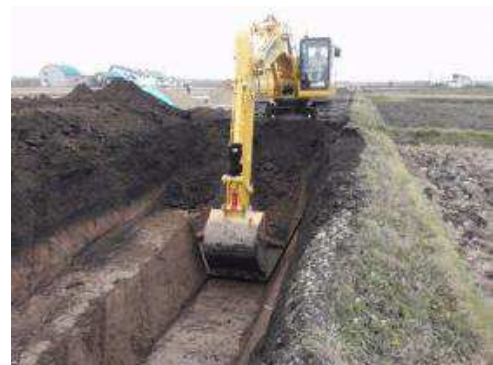
Excavation at the canal construction

The excavation shall be performed to secure the required dimension of structure within the practical extent by digging down to the prescribed level without loosening other part as much as possible and with evenly finished surface as well. When changes in the design parameters are significant enough to raise suspicion regarding the bearing capacity of foundation ground, etc., the safety of structure must be confirmed.

When over digging across the formation level, backfill using gravel and sufficient compaction is necessary.

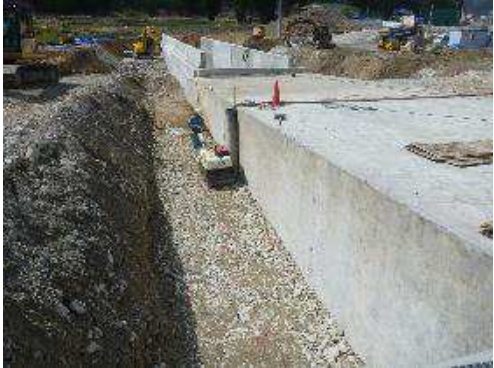
Backfilling at the culvert construction

While the properties of backfill soil conforming to the design conditions shall be used, various things must be removed before starting the work. And during its implementation, the backfilling must be performed with due caution not to impact the structure.

The structure shows its function in a body with the back earth. When the compaction functions sufficiently, encroachment is prevented and it contribute to longer life of the structure.

On the other hand, recognition about the importance of back filling and compaction seems to be not enough in Tanzania, and as for the case which soil is only put in is also observed.

The phenomenon such as crack and collapse of a structure start from washing out of foundation mainly and it should be understood that insufficient back filling is major cause of them.

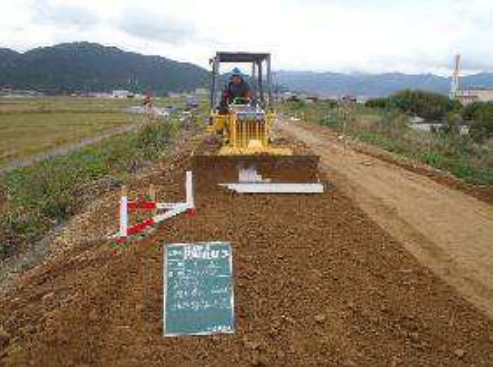
Banking at the road construction

While the material used for banking shall conform to the design conditions, the banking shall be finished with flat surface and the gradient specified in design documents. Also, when banking is performed on ground with steep slope, the adhesion between banking and existing ground must be achieved by measures such as bench cuts, etc. in order to prevent slides.

When banking is performed over soft ground or ground with high groundwater level, drying of the banking bed must be achieved by taking measures such as installation of drainage trenches as early as possible. The banking work under this situation shall be performed with due caution including monitoring the settlement status, etc.

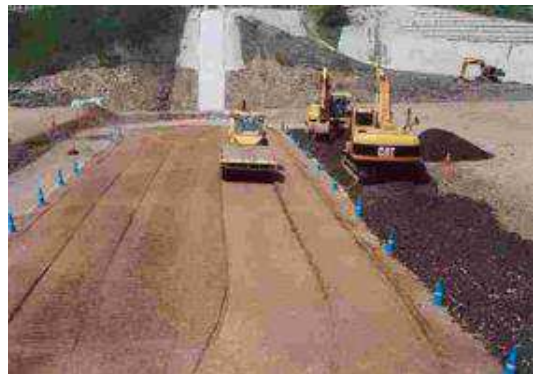
Compaction at the dam construction

Compaction should be continued during maintenance period. It will take a few years for embankment to become stable and firm.

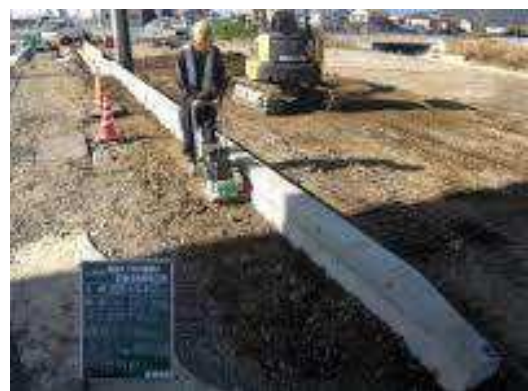
Compaction at the road construction

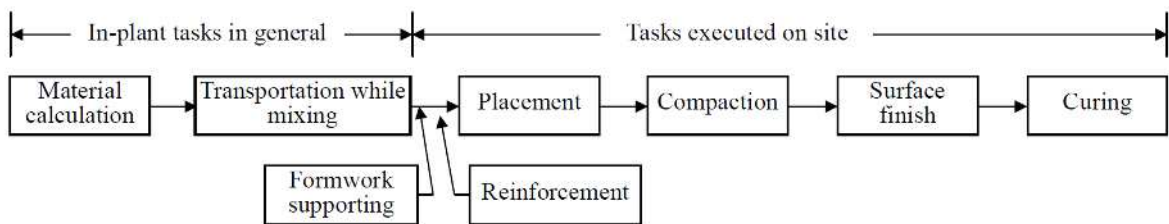
Figure 3-12 Construction sequence in concrete works

The construction sequence in concrete work is as follows. Concrete work flows from material calculation as in-plant tasks to curing as tasks executed on site.

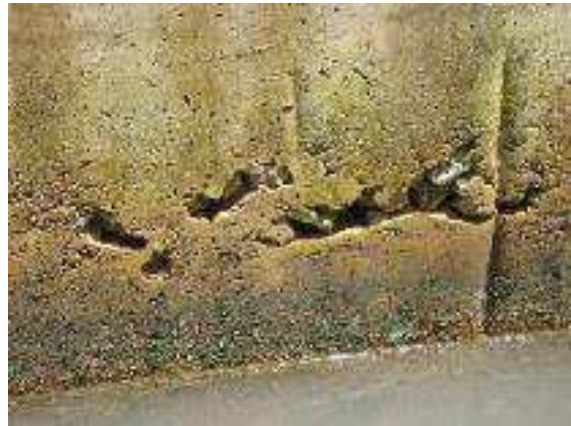
Concrete must be adequately compacted so that the concrete can be packed leaving no space around reinforcing bars and in every corner of formwork. While vibrators (internal/form) are generally used for compaction, the bar-type vibrator is used for canal structures of relatively small scale.

Void caused by insufficient compaction

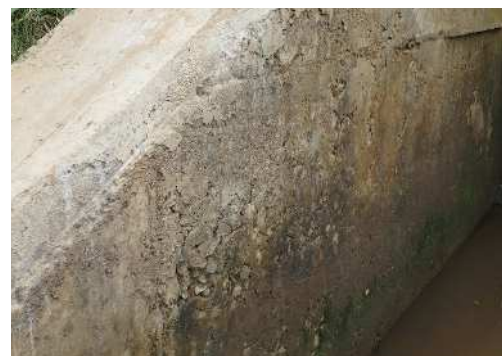
- i. It lessens the compressive strength due to difficulty in integration of the new and old concrete.
- ii. It causes leakages when the construction execution is not perfect.
- iii. In the course of concrete hardening, the new concrete is prevented from shrinking due to restraint imposed by the old concrete, causing cracks, internal stress, compressive stress in the old concrete, and tensile stress in the new concrete. For this reason, the treatment of construction joint must be executed to produce sufficient bonding with the old concrete by removing the laitance or thin paste layer developed on the concrete surface.

Cold joint caused by inadequate manner

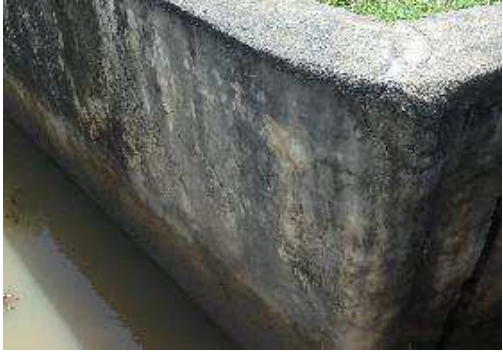
Generally, when the temperature (4 - 25°C) is exceeded during placement or curing of concrete, it is often to sustain adverse impacts such as crack occurrence in addition to delay in strength development or insufficient strength growth.

Hexagonal cracks caused by placing in high temperature condition

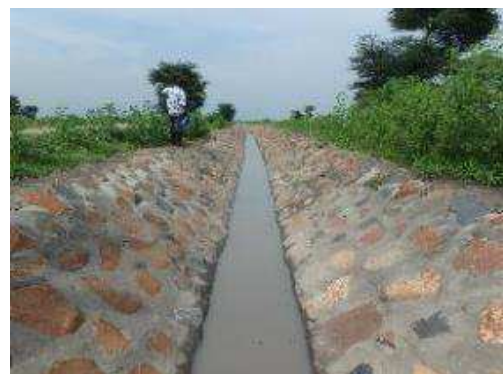
Masonry lining canal  
(Behekala scheme, Igunga, Tabora)

Gaps between stones should be carefully assessed, when washing out of backfilling soils at canal bottom, succeeding subsidence, increasing soil pressure, surface water inflow and unstable foundations develop them, Progressiveness on such phenomena should be monitored.

Moreover, as this type of canals has absolutely complex compiling to shape its structural body, the deformation is expanded on it. Attention should be put on wider zone, i.e. extending to surrounding areas and including part of canal bottom (mainly scouring).

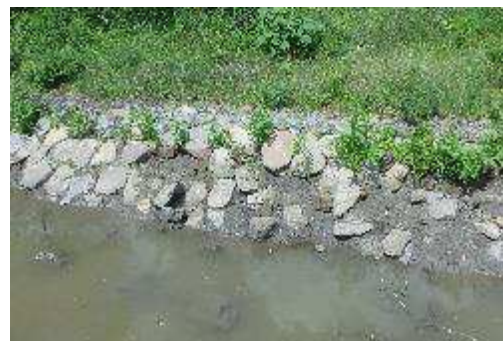
Deficit of masonry caused by  
washing out of backfilling

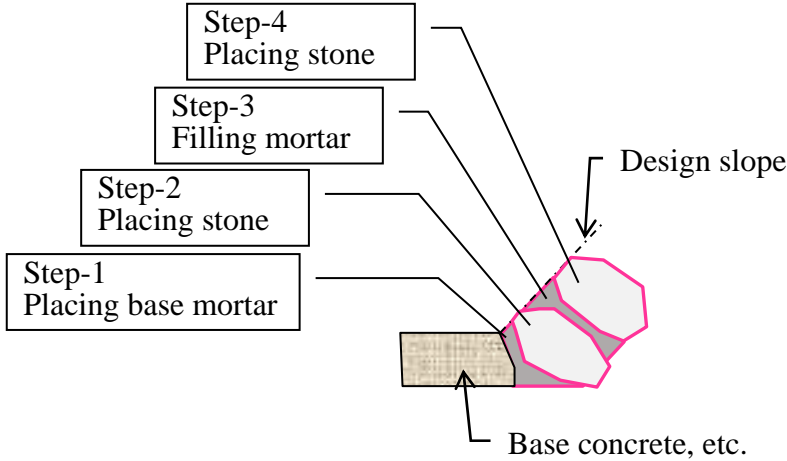
Figure 3-13 Masonry Works

4	Procedure of the Wet Stone Masonry	The wet stone masonry shall be pushed forward in the next procedure.

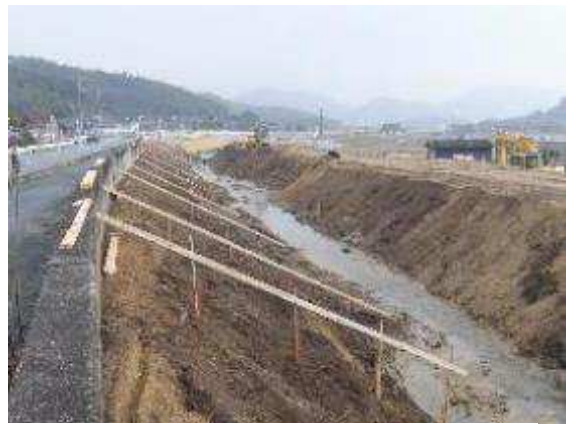
Setting the guide bar for side slope arrangement

Prior to construction start, installation of the guide bar indicating the design height and width, gradient each station points should be carried out.

In installation of guide bar, the collations of the design level becoming basic of the guide bar such as design vertical section figure, figure of cross-section and structure should be performed before work.

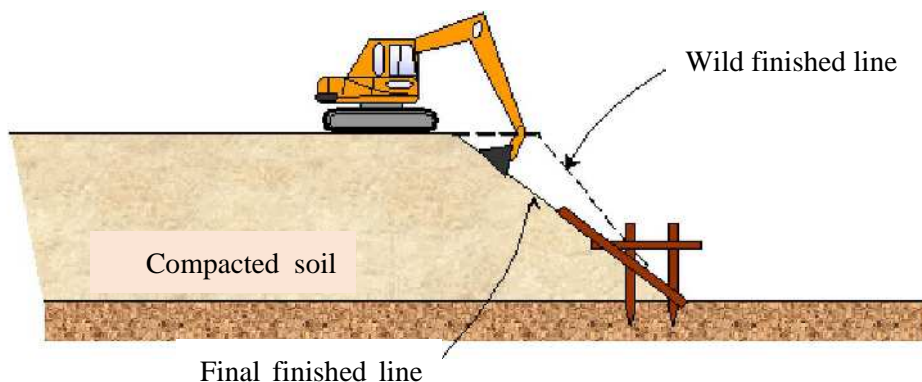
Figure 3-14 Image of earth work procedure

Example of arranging the earth work procedure (banking and slope finish) using guide bar is as follows;

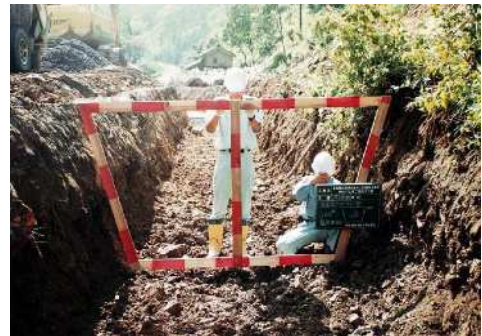
- The photograph needs to be able to confirm not only the result of dimension measurement at this point but also backward continuity in an angle.
- When it is necessary to perform quality management, the records of confirmation work shall be attached.

Finishing excavation

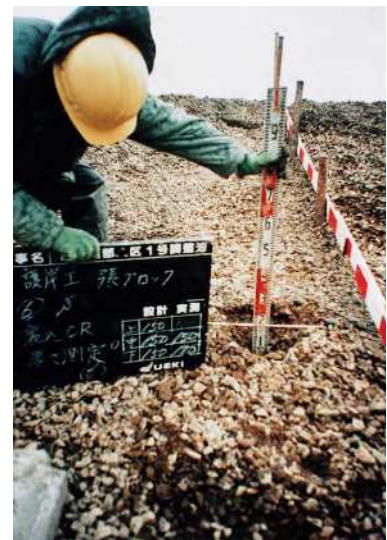
- The photograph should be taken to understand the situation and the thickness of backfilling, and the measurement result shall be attached on black board.
- It is better that the angle of the camera will be set in a right angle to confirm the thickness.

Finishing backfilling

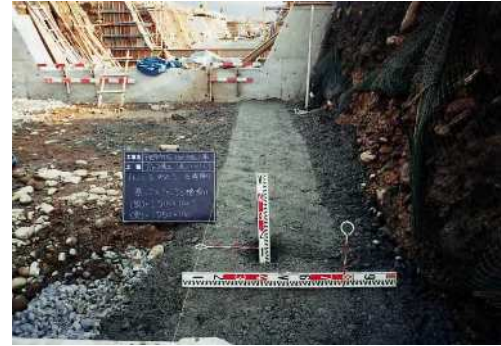
- Because of using pin pole and measuring rods, both of thickness and width can be confirmed.
- It is better if the height of basement surface and relation to surrounding structures can be made out from this picture.

Finishing basement

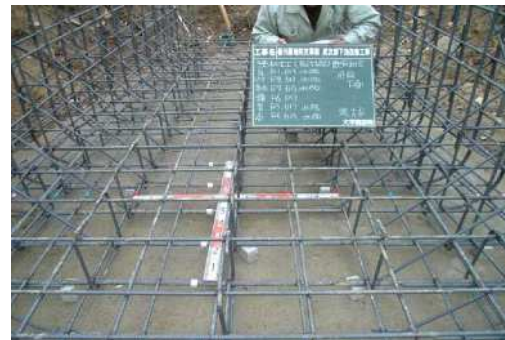
- The setting situation of reinforcing bars and interval between bars can be observed.
- When there are many marking points, additional photograph from different angle shall be needed.
- If this is important structure such as head work or bridge, the confirmation of supervision staff at the site is necessary.

Finishing reinforcing bar setting

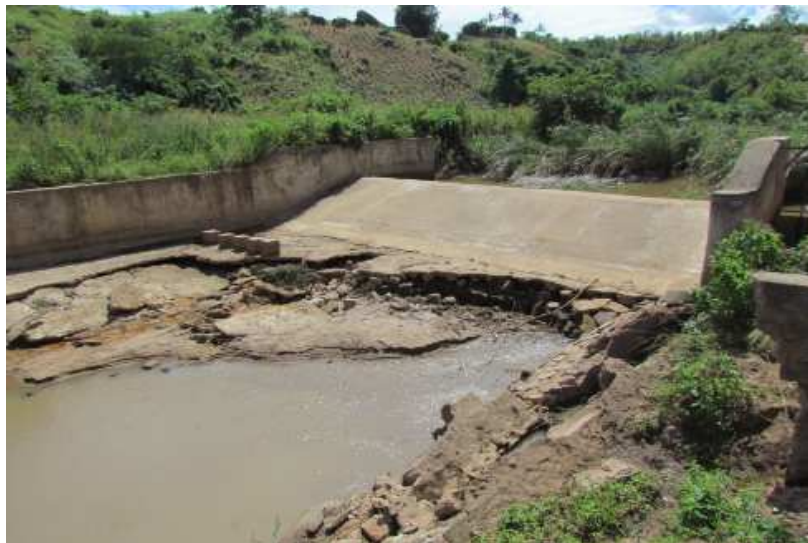
Cause	Solution
Piping (excessive seepage) caused by cut off walls was being too short.	Install cut-off wall upstream (2.0m), middle cut off wall (2.0m) and downstream cut off wall (0.7m) considering the soil type (sand) which brings excessive seepage.
Hydraulic jump-thickness of the base concrete was very small (almost 20cm) to withstand flood power.	Increased thickness of base concrete with stony masonry to prevent seepage to form stable foundation and to prevent hydraulic jump.
Construction management / poor supervision to the contractor.	District is empowering PC to check the quality of the concrete work. District has conducted dimension control especially length of cut-off walls, depth of base concrete using control sheet.

Base concrete washed away and hydraulic jump broken by piping and flood power.

Placing the base concrete with stone masonry.

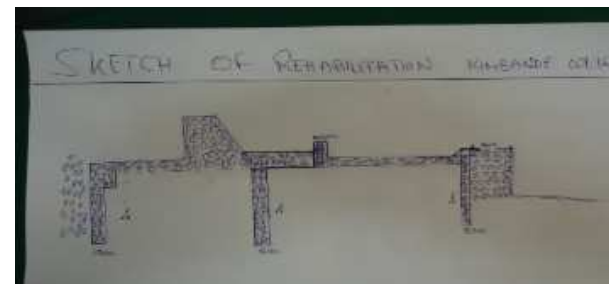
Planned longitudinal cross-section. 3 types of cut-off wall were designed considering soil type (sand).

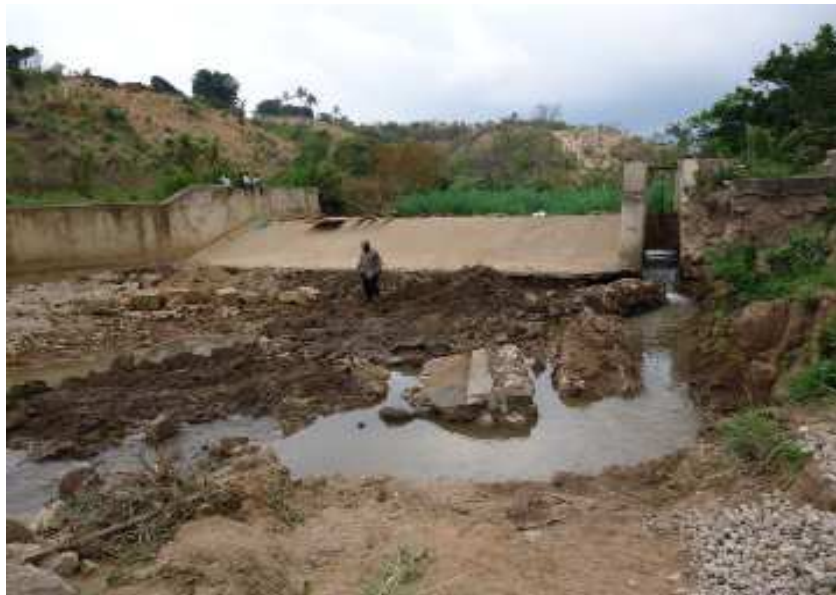
Cause	Solution
Depth of the embedment was affected by scouring / erosion done by flood water	Increased depth of the embedment to 1.2m from the base of downstream apron.
Depth and width were not enough to protect from piping considering the soil type (sand soil).	Used trapezoidal shape and retaining wall for the side walls and 1.5m as a base.

Left side wall collapsed by scouring / erosion occurred by flood water. (View from downstream)

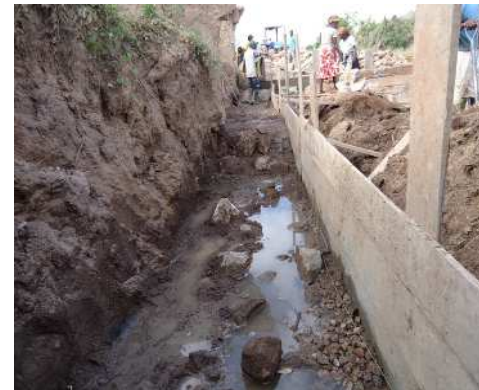
Increased depth of the embedment to 1.2m from the base of downstream apron.

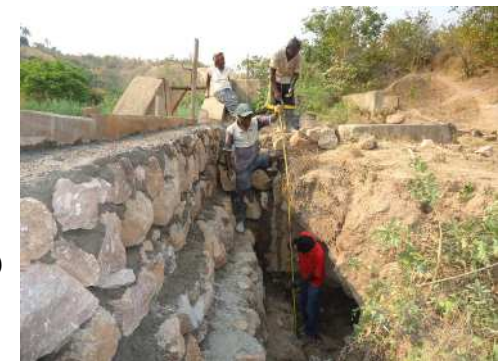
Dimension (depth of the wall) is taken after completion of concrete work.

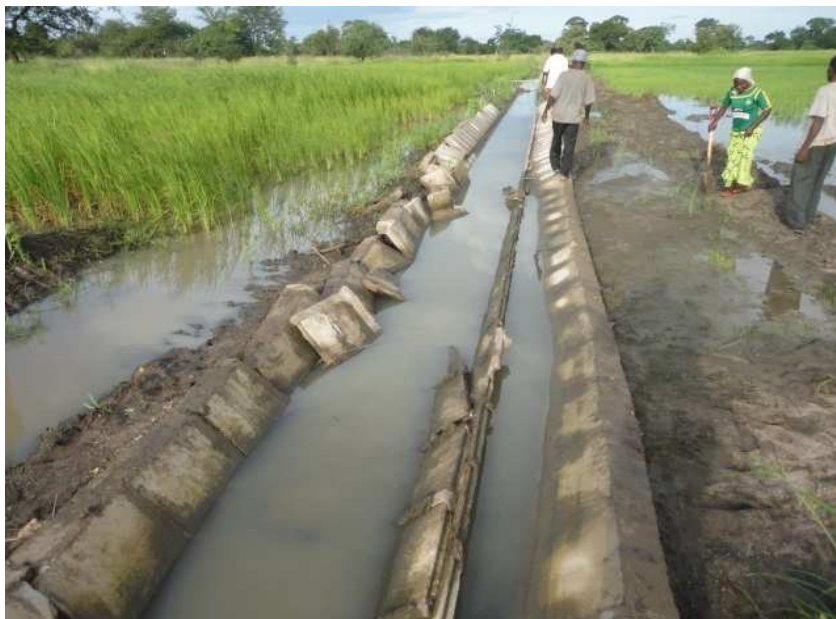
Cause	Solution
Infiltrating rain water besides the canal top on the left canal bank.	Construction of non silting, non eroding left collector drain along the main canal with adequate dimension, bed slope, (0.001 to 0.0005) with well compaction and lead water into a drift.
Inadequate top concrete cover.	Provision of adequate top concrete 200mm wide x 100mm thick.

Bulging of main canal sides and cracks on slab joints caused by heavy rains with floods. (over-topping)

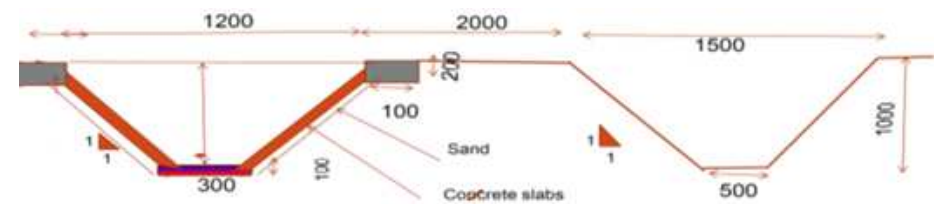
Planned cross-section of main canal with collector drain.

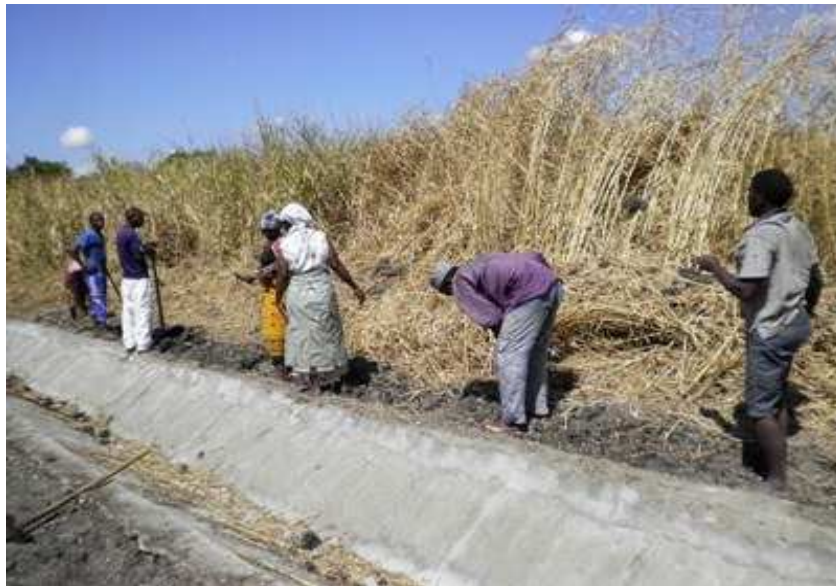
Backfilling was imported and compacted using good type of soil.

Cause	Solution
Soil type (black cotton soil), poor compaction.	Import and compact good soil rather than black cotton.

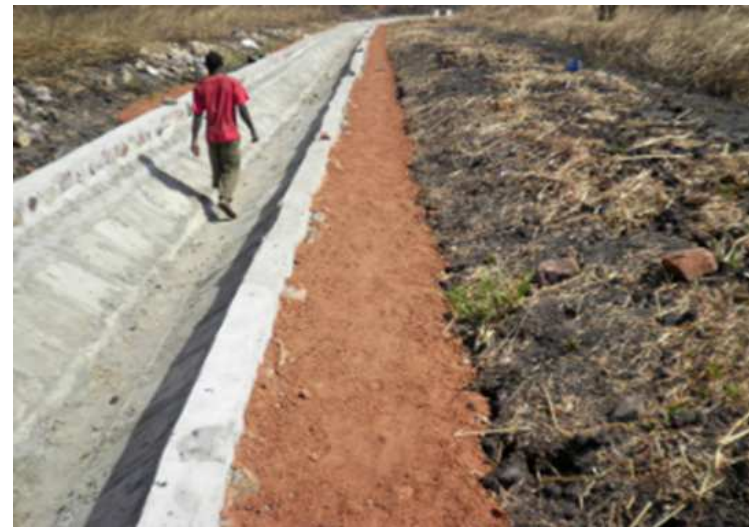
Cracked canal side wall caused by black cotton soil and poor compaction

Note: Black cotton soil (Vertisols: Name of Soil Orders in Soil Taxonomy)  
 The central concept of Vertisols is that of soils that have a high content (>30%) of expanding clay known as montmorillonite and that have at some time of the year deep wide cracks. They shrink when drying and swell when they become wetter. The shrinking and swelling of Vertisols can damage buildings and roads, leading to extensive subsidence.

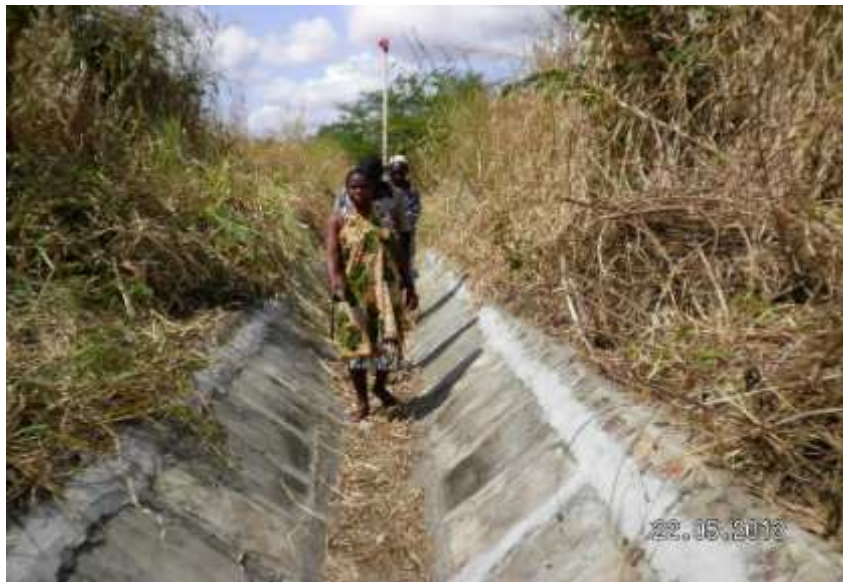
Some fields do not get irrigation water efficiently by differential settlement of the canal. Zone and District staff confirm the height of the canal bed and longitudinal slope.

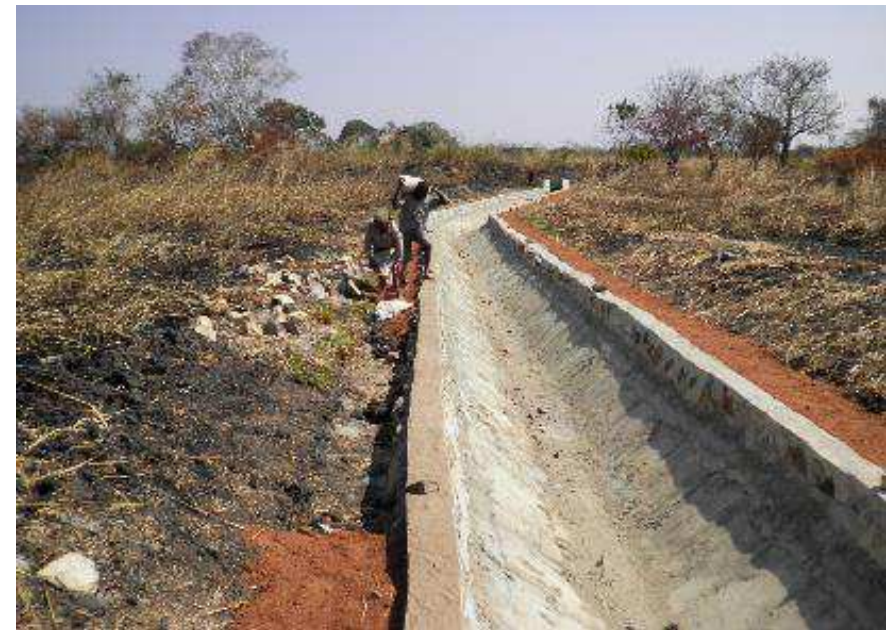
After survey work, IO decided to rise canal bed level by 0.20m and top bank level by 0,25m respectively. After that, backfilling was compacted enough to keep good condition for facility.

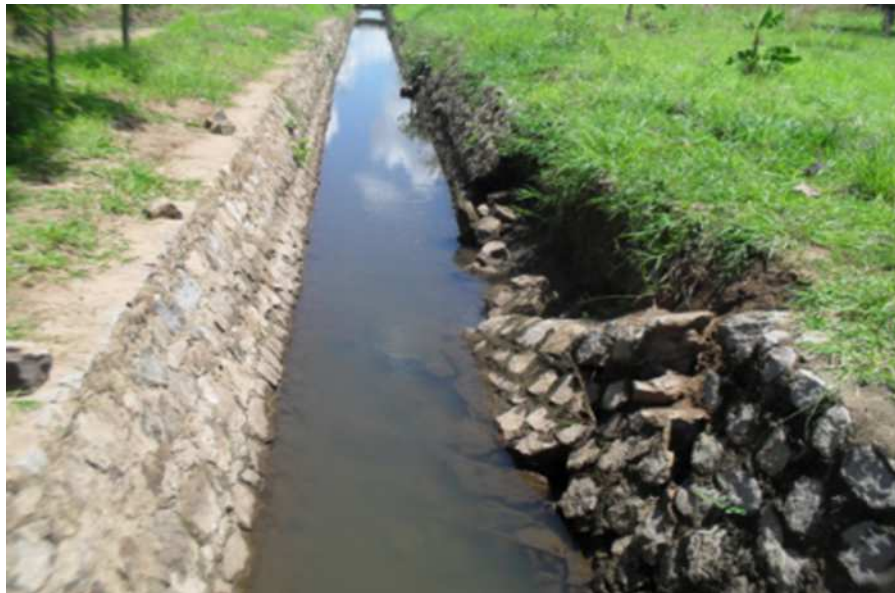
Side wall of main canal constructed by masonry collapsed. Some factors are picked up as the cause of this problem through the cause analysis.

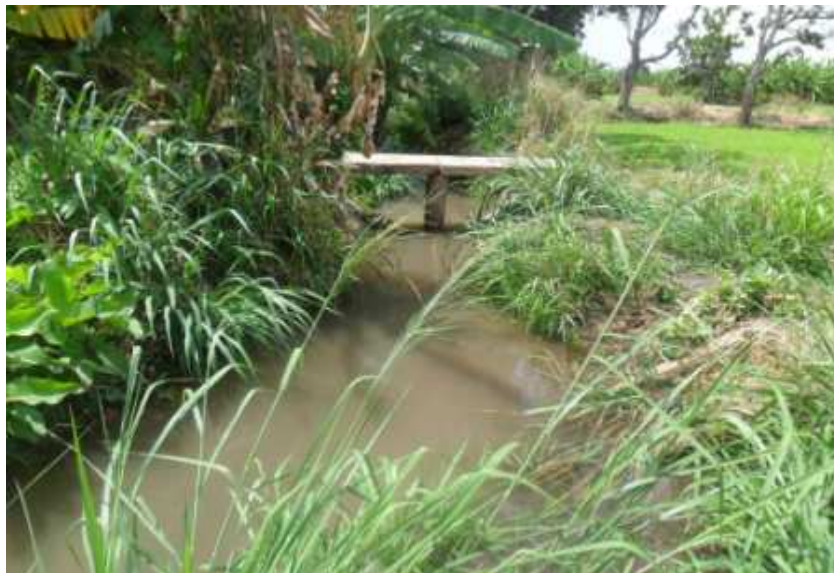
Since foot bridge was not protected from scouring, irrigation water was logging and seepage occurred.

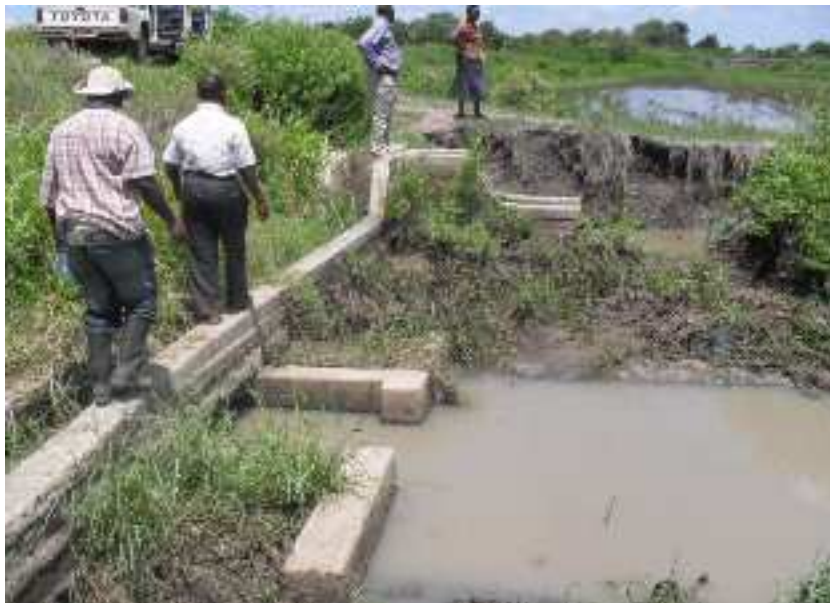
Secondary canal collapsed by flood water from adjacent pond. It was clarified that 5 Diversion boxes are out of order after Participatory Diagnostic Study.

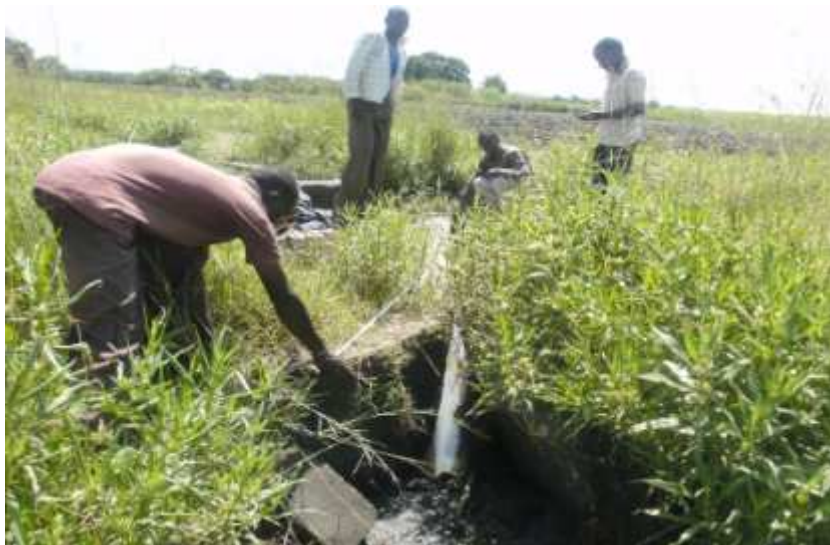
Vertical walls of the distribution boxes collapsed to the inside due to poor construction and abnormal earth pressure caused by black cotton soil.

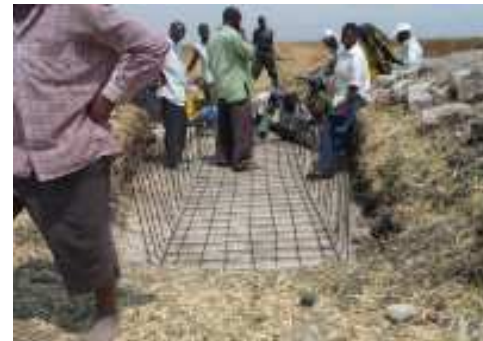
Reinforcing bar setting on the well compacted foundation.

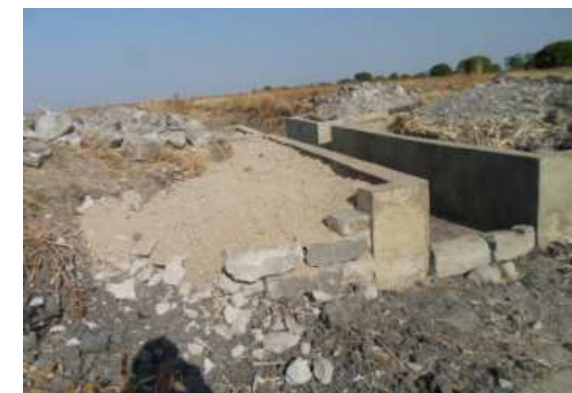
Compacted using crashed ole structure and morram beside the walls

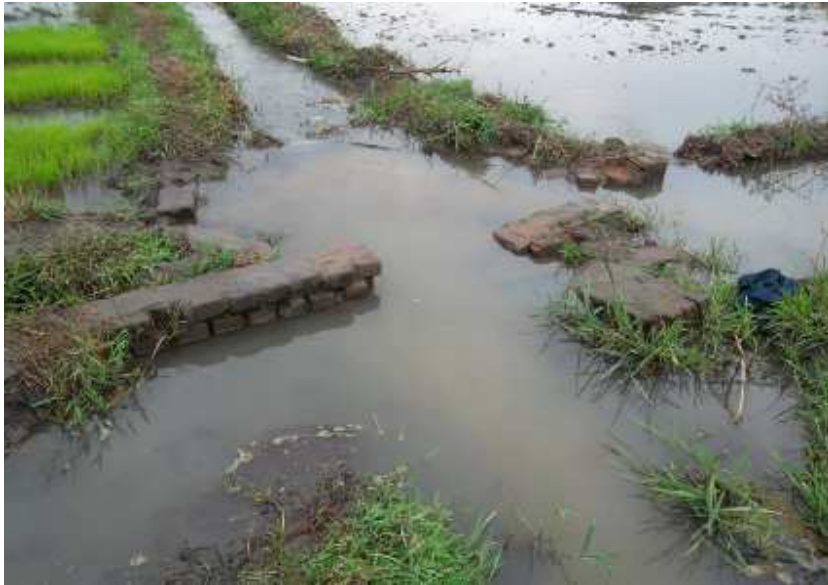
#### 4.2.9 Collapse of division box (Minepa, Ulanga, Morogoro)

Cause	Solution
Flood water	Reconstruction of new division box (activity by farmers)

Collapsed division box is selected as main problem after Participatory Diagnostic Study.

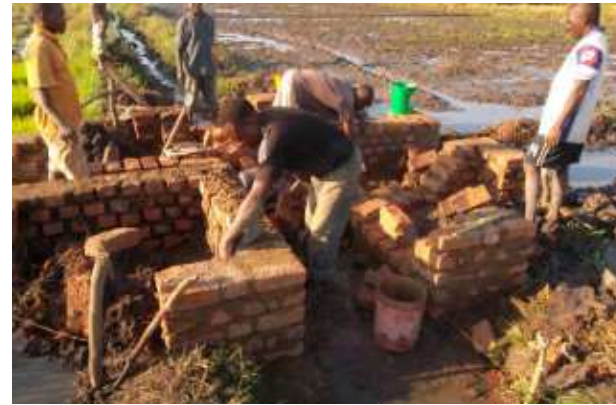
Farmers constructed division box using bricks.

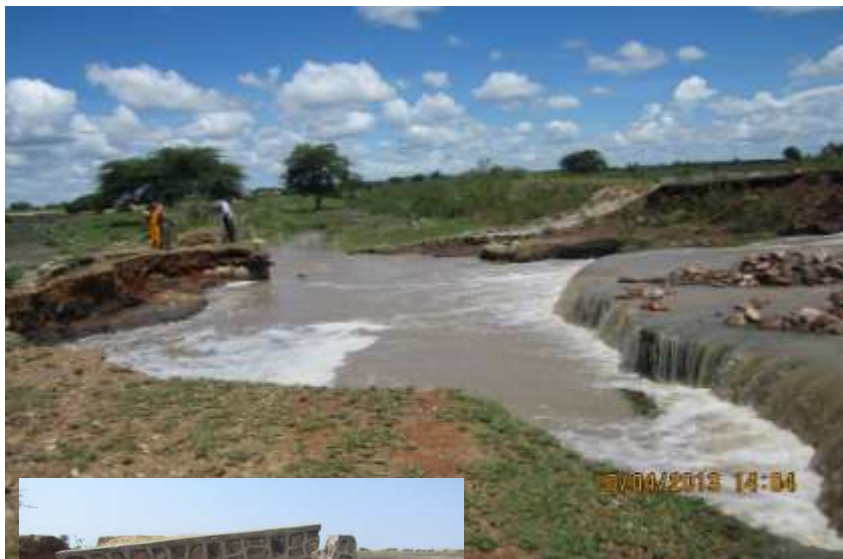
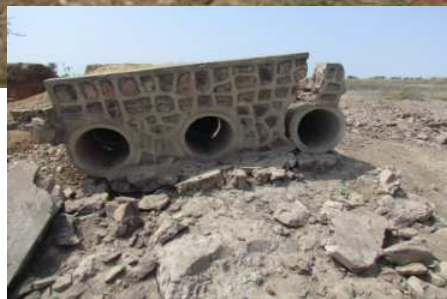
#### 4.3.1 Frequent bleaching of main canal banks (Lusu, Nzega, Tabora)

Cause	Solution
Poor quality earth fill soil (permeable) used to form the canal bunds.	Reconstruction of the broken main canal bund by use of suitable material.
Narrow main canal with low capacity.	Widen the main canal
Low capacity of culvert few meters downstream the spillway.	Reconstruct the bridge with adequate capacity
Side spillway is inadequate (small)	Widen the spillway to increase capacity.

The scheme conveyance system was seriously destroyed by floods.

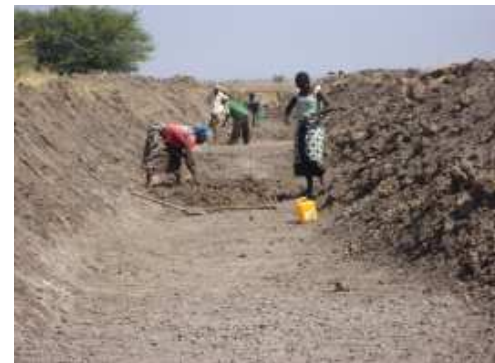
The main canal was widening by farmers' contribution.

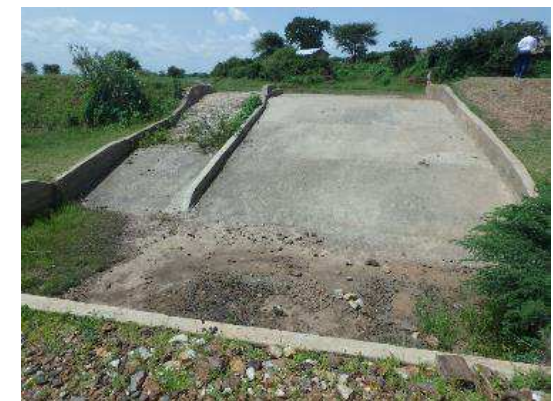
Additional spill way (right side) completed.

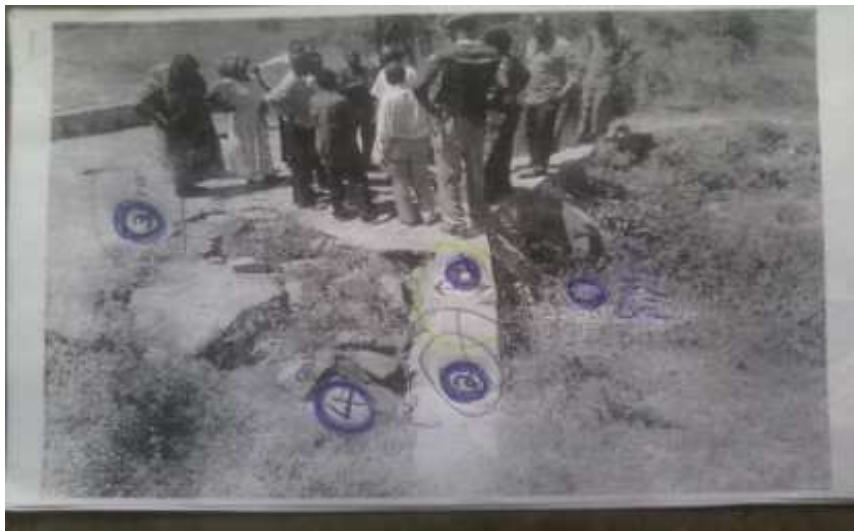
Vented drift with one line of concrete pipe culvert was destructed by the overflow of the water.

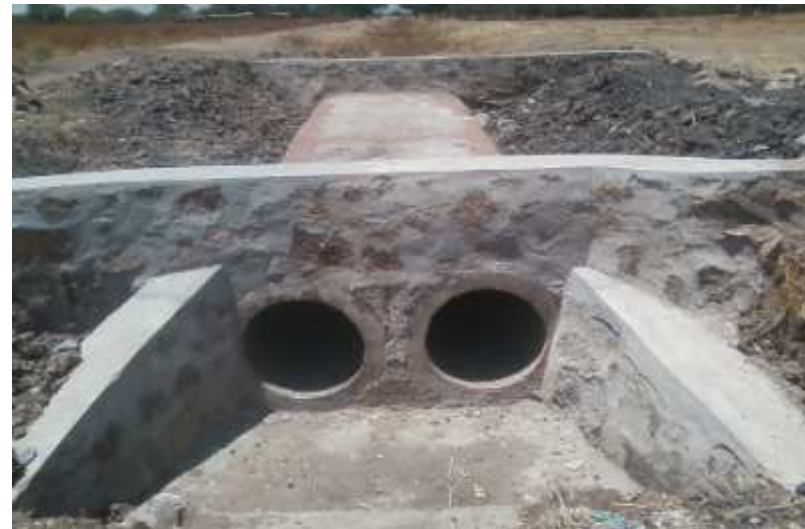
Two concrete pipes will allow more water to pass through and prevent overtopping. Moreover, the wing walls which prevent scouring hence no seepage were installed at the entrance of the pipes.
